# ENGINEERING CONDITION SURVEY AND STRUCTURAL INVESTIGATION OF MONTGOMERY LOCKS AND DAM OHIO RIVER

March 1977

Final Report

Prepared for U. S. Army Engineer District, Pittsburgh  
Pittsburgh, Pa. 15222

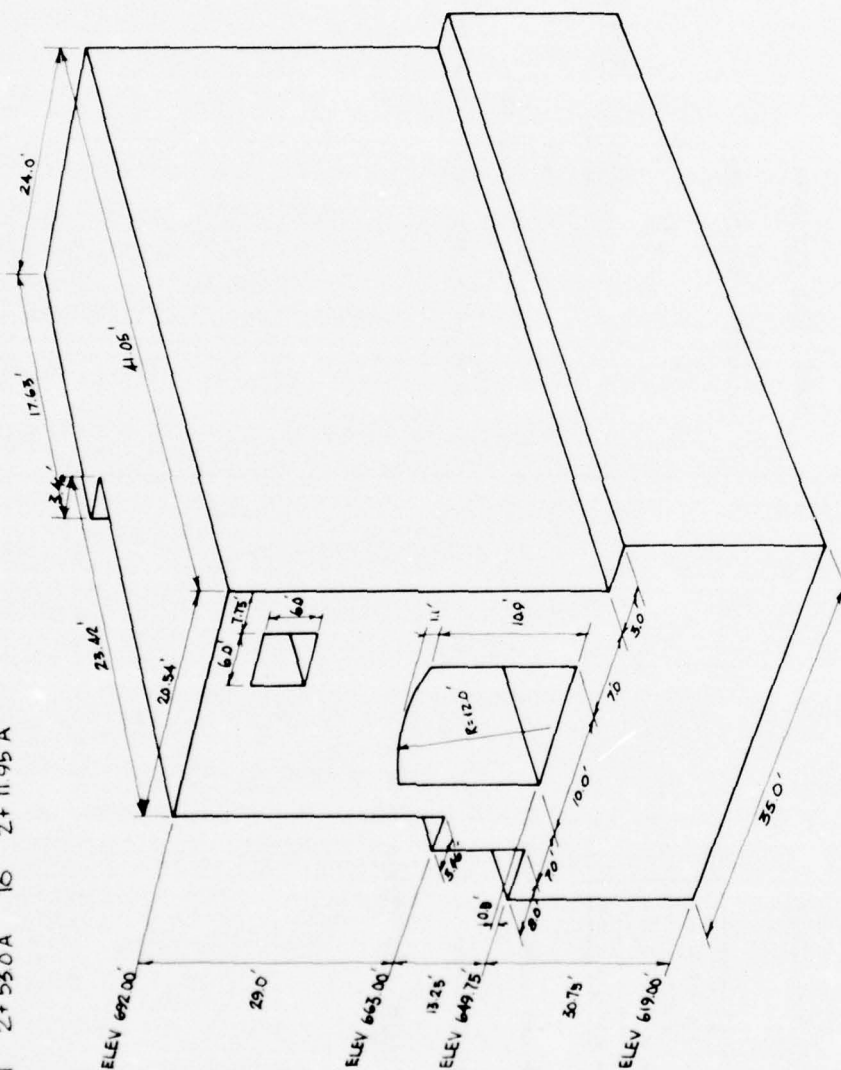
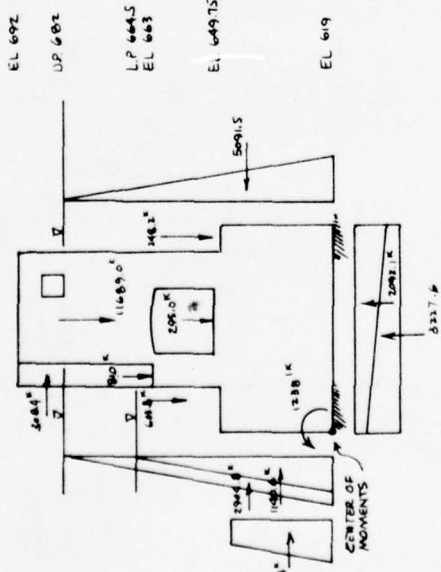
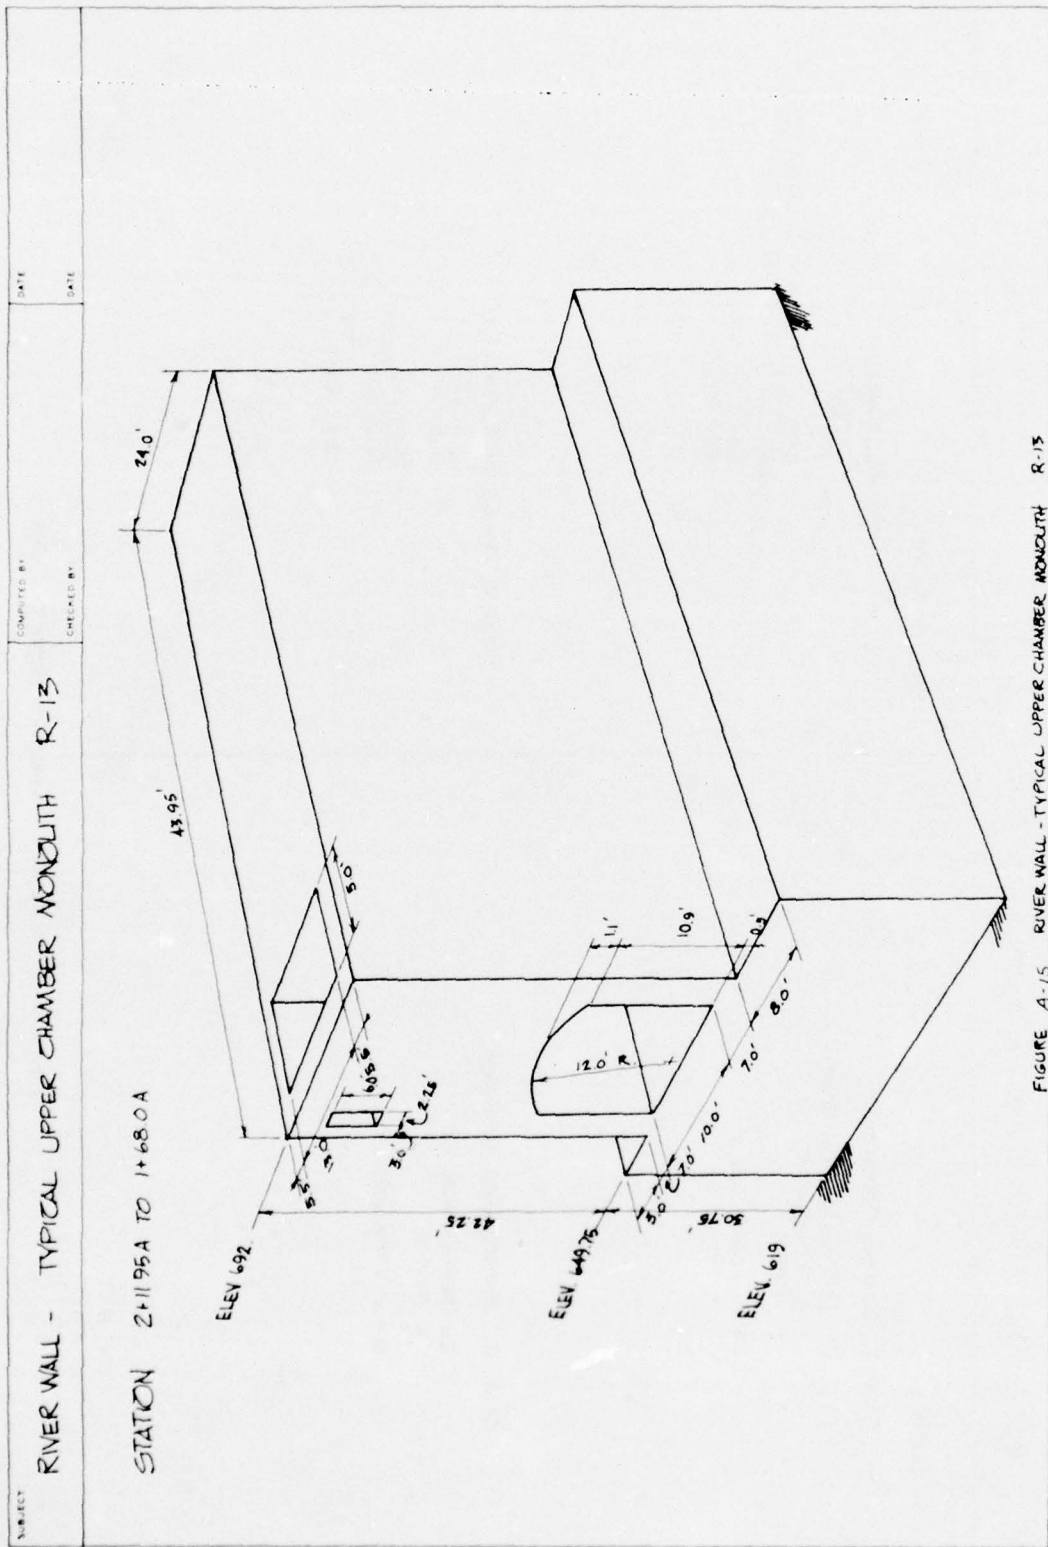
FIGURE A-14 RIVER WALL - UPPER GATE MONOLITH R-12

6.20 The loadings for monolith R-12 are given in Figure 6.17. The total stress plot for the normal operating case is the more critical and is given in Figure 6.18. The monolith section depicting the areas ("E" and "F") of stress conditions is given in Figure 6.19. The depicted

areas of stress concentration are given in Figures 6.20 and 6.21. The stresses due to gate and other loadings do not produce excessive stresses in this monolith. The cracking in this monolith is small and is at discontinuities or cutouts.

$\theta = \frac{136451}{75973} = 17.96$   
 PERCENT ACTIVE BASE =  $\frac{(17.06)(3)(100)}{35} = 100\%$   
 $F.S. = \frac{\sum STABILIZING M}{\sum OVERTURNING M} = \frac{335695}{199144} = 1.68$

SUBJECT	COMPUTED BY	DATE
RIVER WALL - UPPER GATE MONOLITH R-12		
<p><b>SLIDING</b></p> <p><b>CASE I NORMAL OPERATIONS</b></p> $R = \sum F_v \tan \phi + \text{key Resistance}$ $= (7597.3)(5658) + 0$ $= 4298.6$ $SSF = 4298.6 / 386.3$ $= 11.1$		
<p><b>CASE II MAINTENANCE CONDITION</b></p> $R = (9189.6)(5658) + 0$ $= 5199.5$ $SSF = 5199.5 / 4740.1$ $= 1.1$		
<p><b>BASE PRESSURE</b></p> <p><b>CASE I NORMAL OPERATIONS</b></p> $f = \frac{P}{A} + \frac{M_c}{I}$ $= \frac{7597.3}{(35)(41.05)} + \frac{(7597.3)(17.96 - 17.5)(17.5)(12)}{(41.05)(35)^3}$ $= 5.29 \quad 0.42$ $= 5.71 \text{ KSF}$		
<p><b>CASE II MAINTENANCE CONDITION</b></p> $f = \frac{2}{3} \frac{P}{C} / L$ $= \frac{(2)(9189.6)}{(3)(6.36)} / 4.05$ $= 23.47 \text{ KSF}$

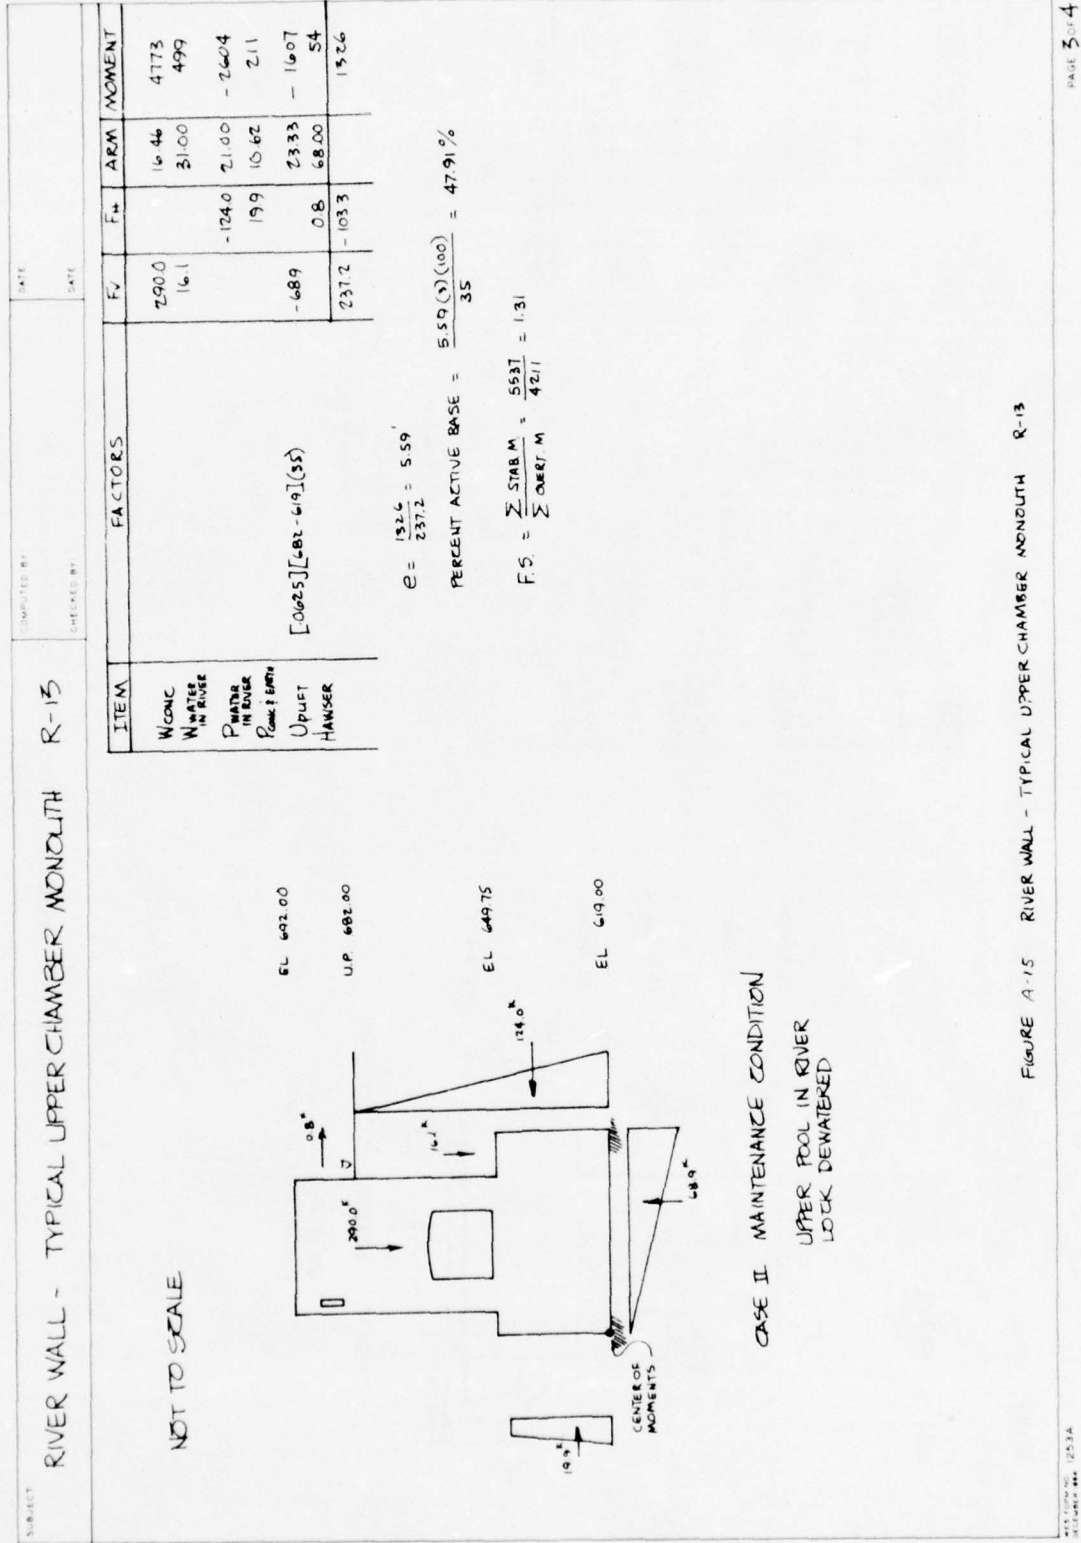
FIGURE A-15 RIVER WALL - TYPICAL UPPER CHAMBER MONOLITH R-13

SUBJECT	COMPUTED BY	DATE
RIVER WALL - TYPICAL UPPER CHAMBER MONOLITH R-13	CHECKED BY	DATE
<p>SLIDING</p> <p>CASE I NORMAL OPERATIONS</p> $R = \sum F_v \tan \phi + \text{KEY RESISTANCE}$ $= (1974)(.5658) + 0$ $= 1117$ $SSF = 1117 / 377 = 2.96$	<p>BASE PRESSURE</p> <p>CASE I NORMAL OPERATIONS</p> $f = \frac{2}{3} \frac{P}{e}$ $= \frac{(2)(1974)}{(3)(953)}$ $= 13.81 \text{ KSF}$	
<p>CASE II MAINTENANCE CONDITION</p> $R = \frac{(2372)(.5658)}{1342} + 0$ $SSF = 1342 / 1033 = 1.30$	<p>CASE II MAINTENANCE CONDITION</p> $f = \frac{2}{3} \frac{P}{e}$ $= \frac{(2)(2372)}{(3)(659)}$ $= 28.29 \text{ KSF}$

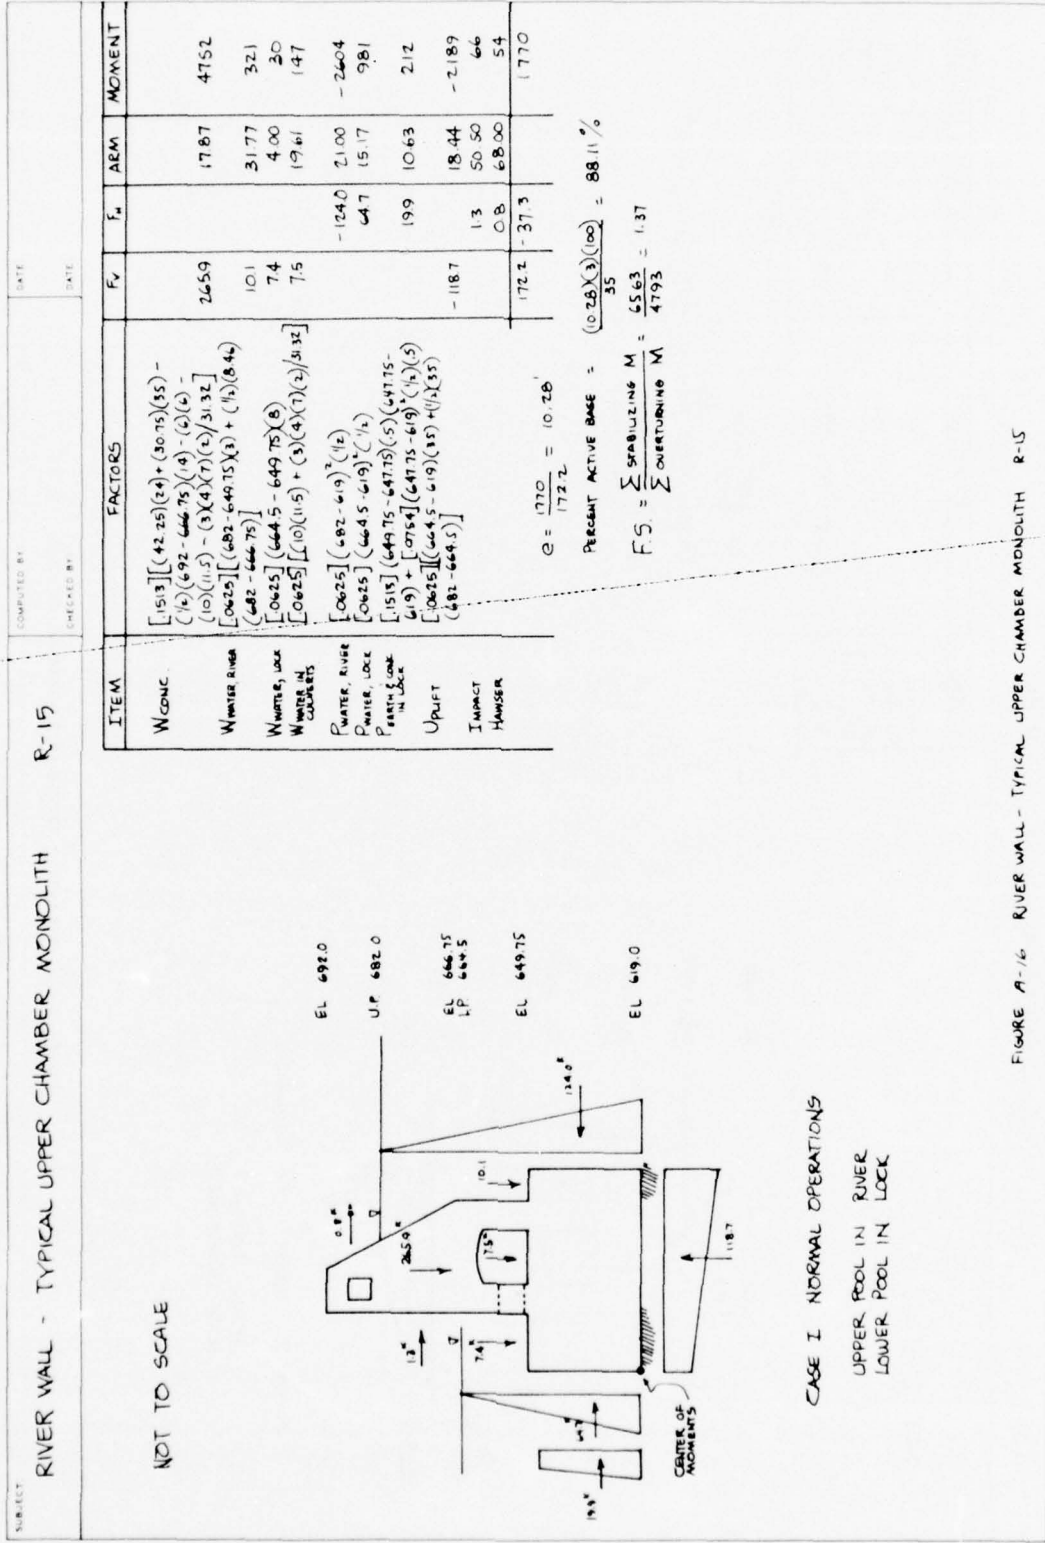
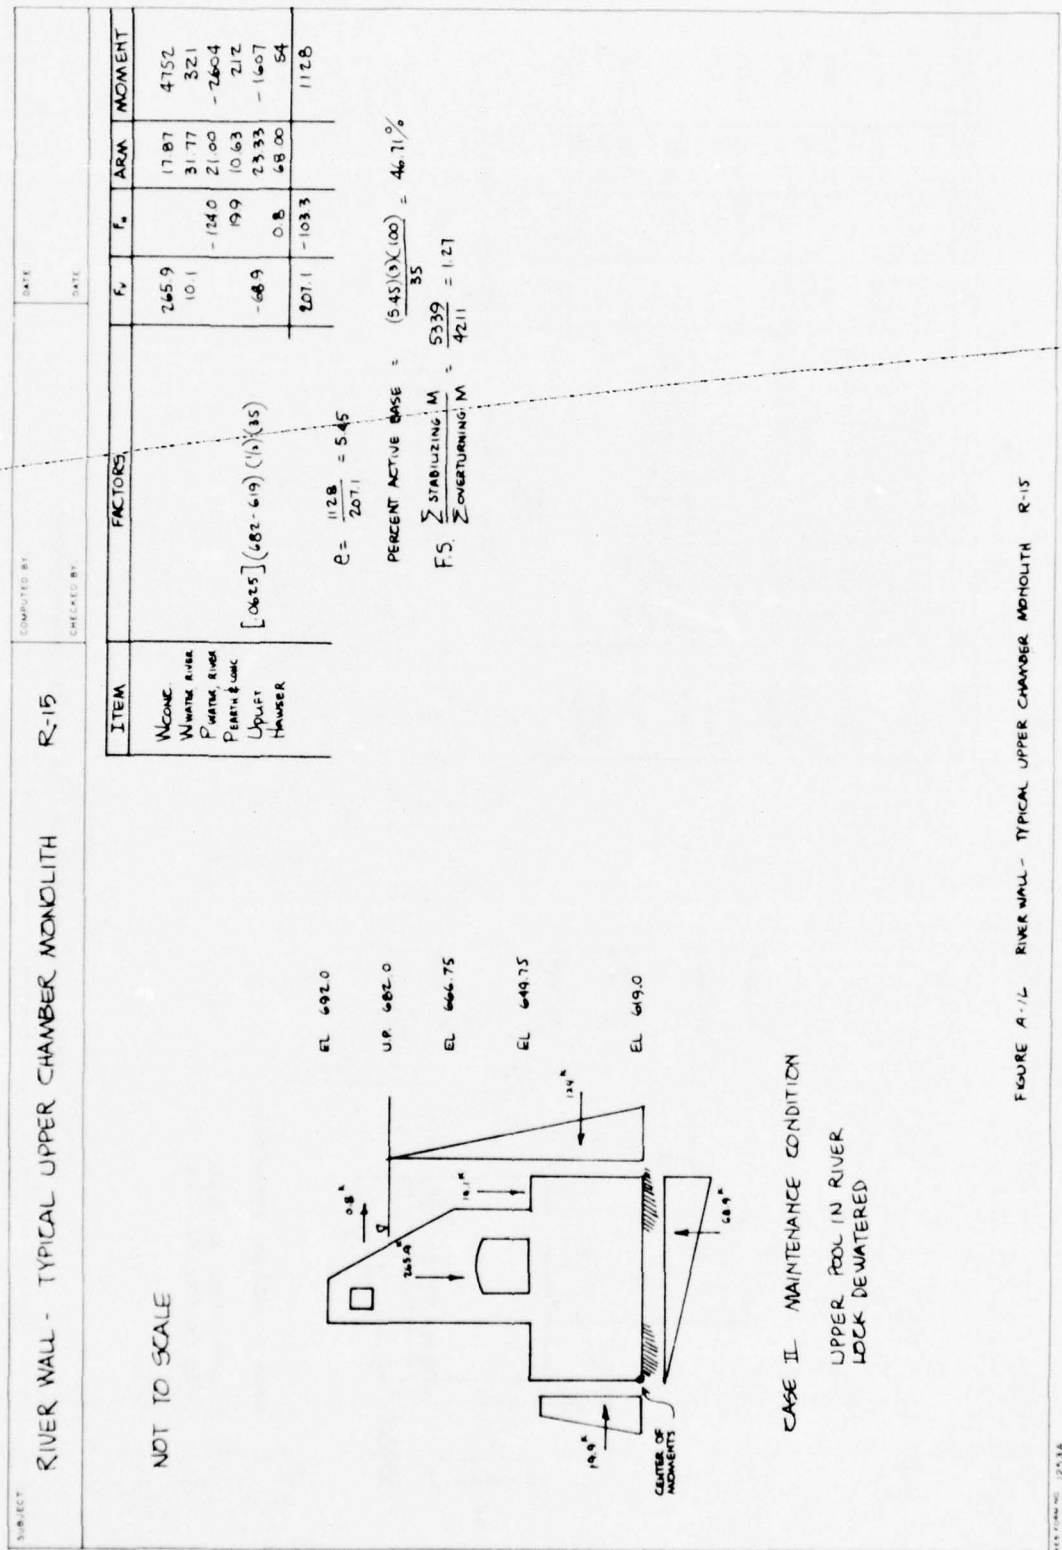
SUBJECT	COMPUTED BY	DATE
RIVER WALL - TYPICAL UPPER CHAMBER MONOLITH	R-15	
SLIDING  CASE I NORMAL OPERATIONS  $R = \sum F_v \tan \phi + \text{KEY RESISTANCE}$ $= (172.2)(56.58) + 0$ $= 97.4$ $SSF = 97.4 / 37.3$ $= 2.61$	BASE PRESSURE  CASE I NORMAL OPERATIONS  $f = \frac{2}{3} \frac{P}{Q}$ $= \frac{(2)(172.2)}{(3)(10.18)}$ $= 11.17 \text{ KSF}$	
CASE II MAINTENANCE CONDITION  $R = (207.1)(56.58) + 0$ $= 117.2$ $SSF = (17.2) / 103.3$ $= 1.13$	CASE II MAINTENANCE CONDITION  $f = \frac{2}{3} \frac{P}{Q}$ $= \frac{(2)(207.1)}{(3)(5.45)}$ $= 25.33 \text{ KSF}$	
FIGURE A-16 RIVER WALL - TYPICAL UPPER CHAMBER MONOLITH	R-15

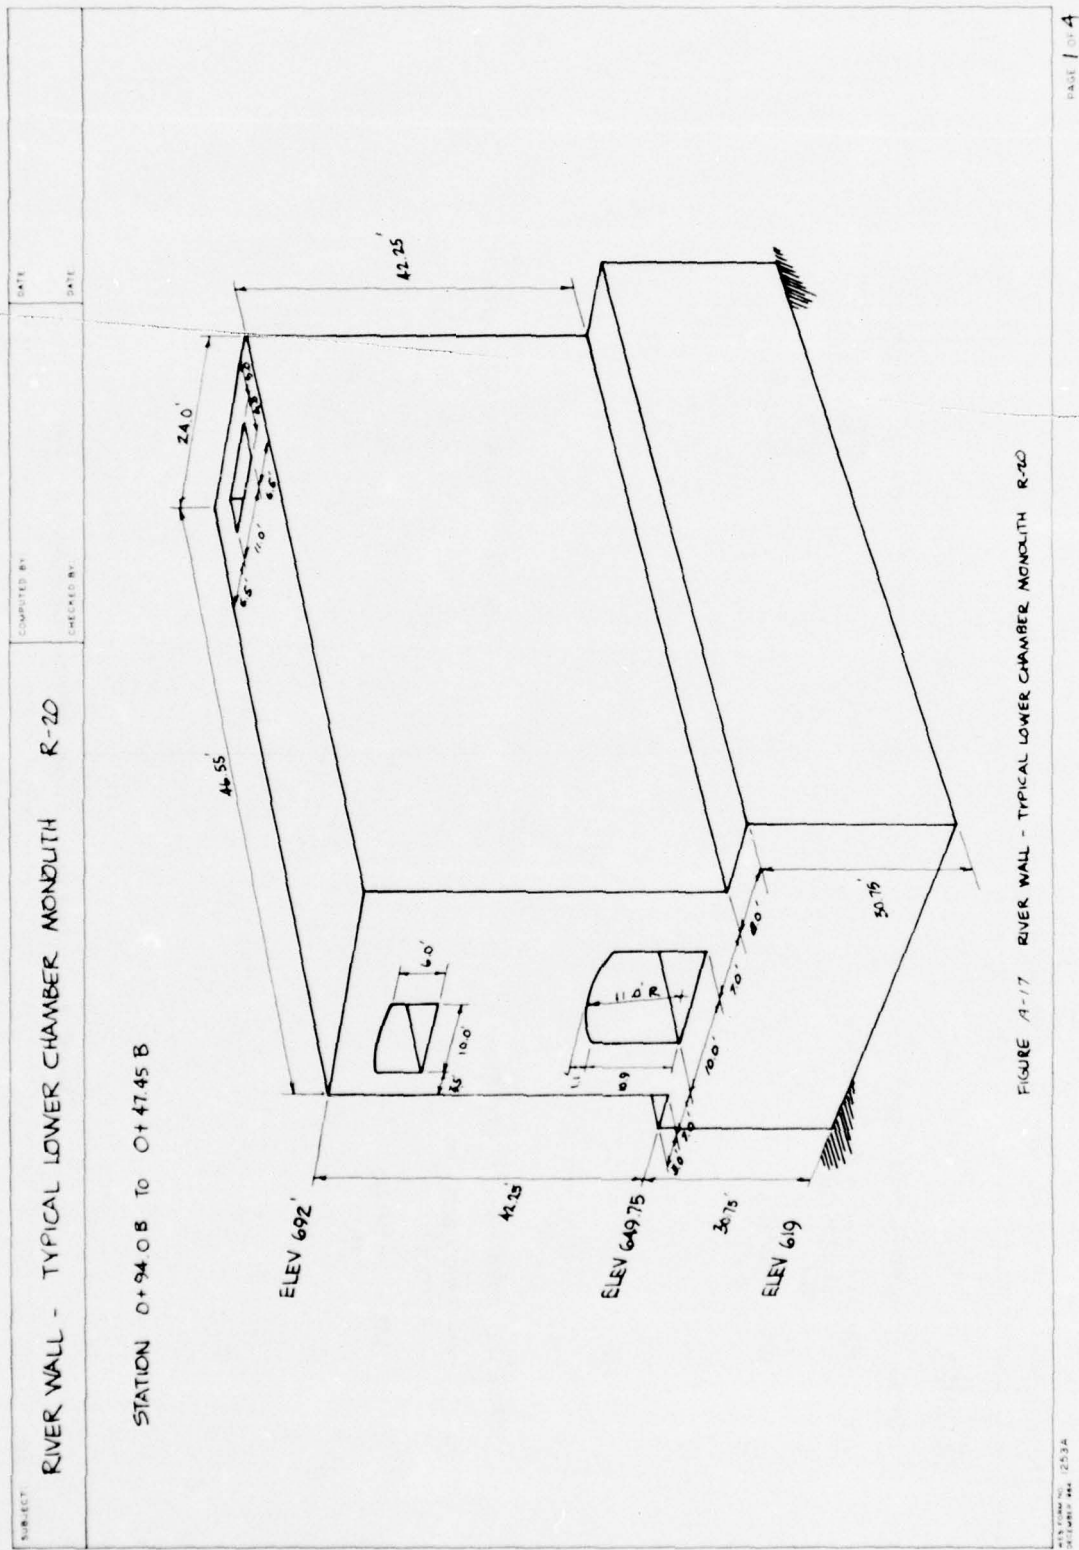
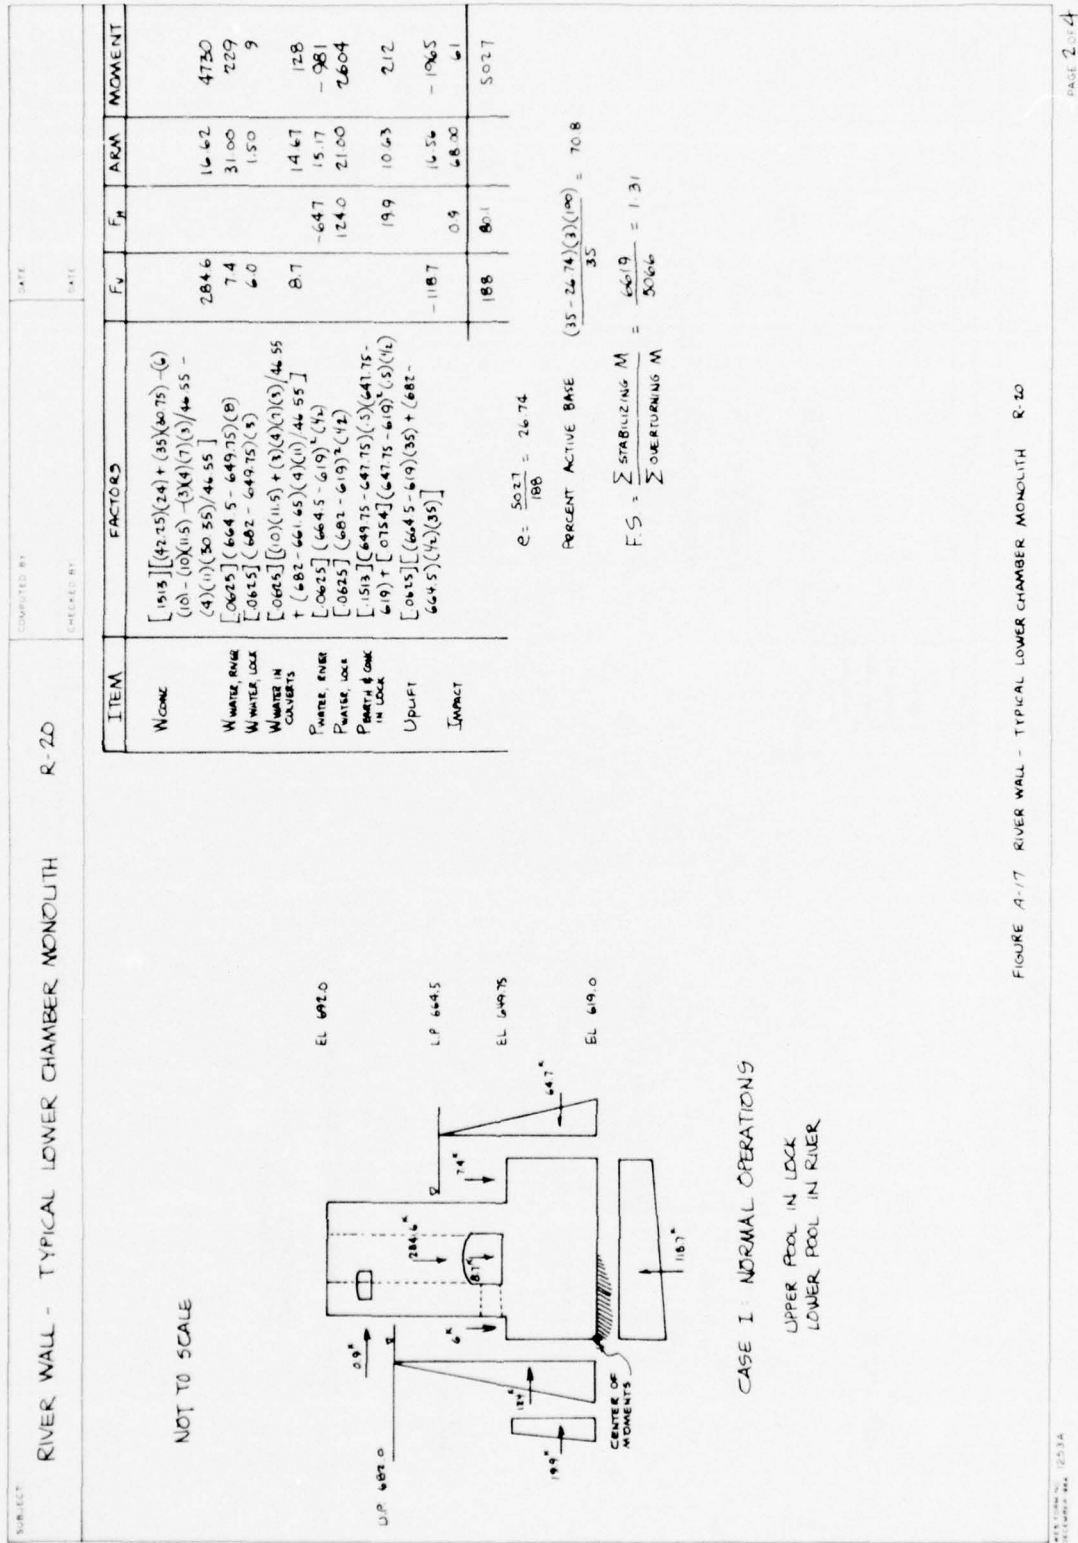
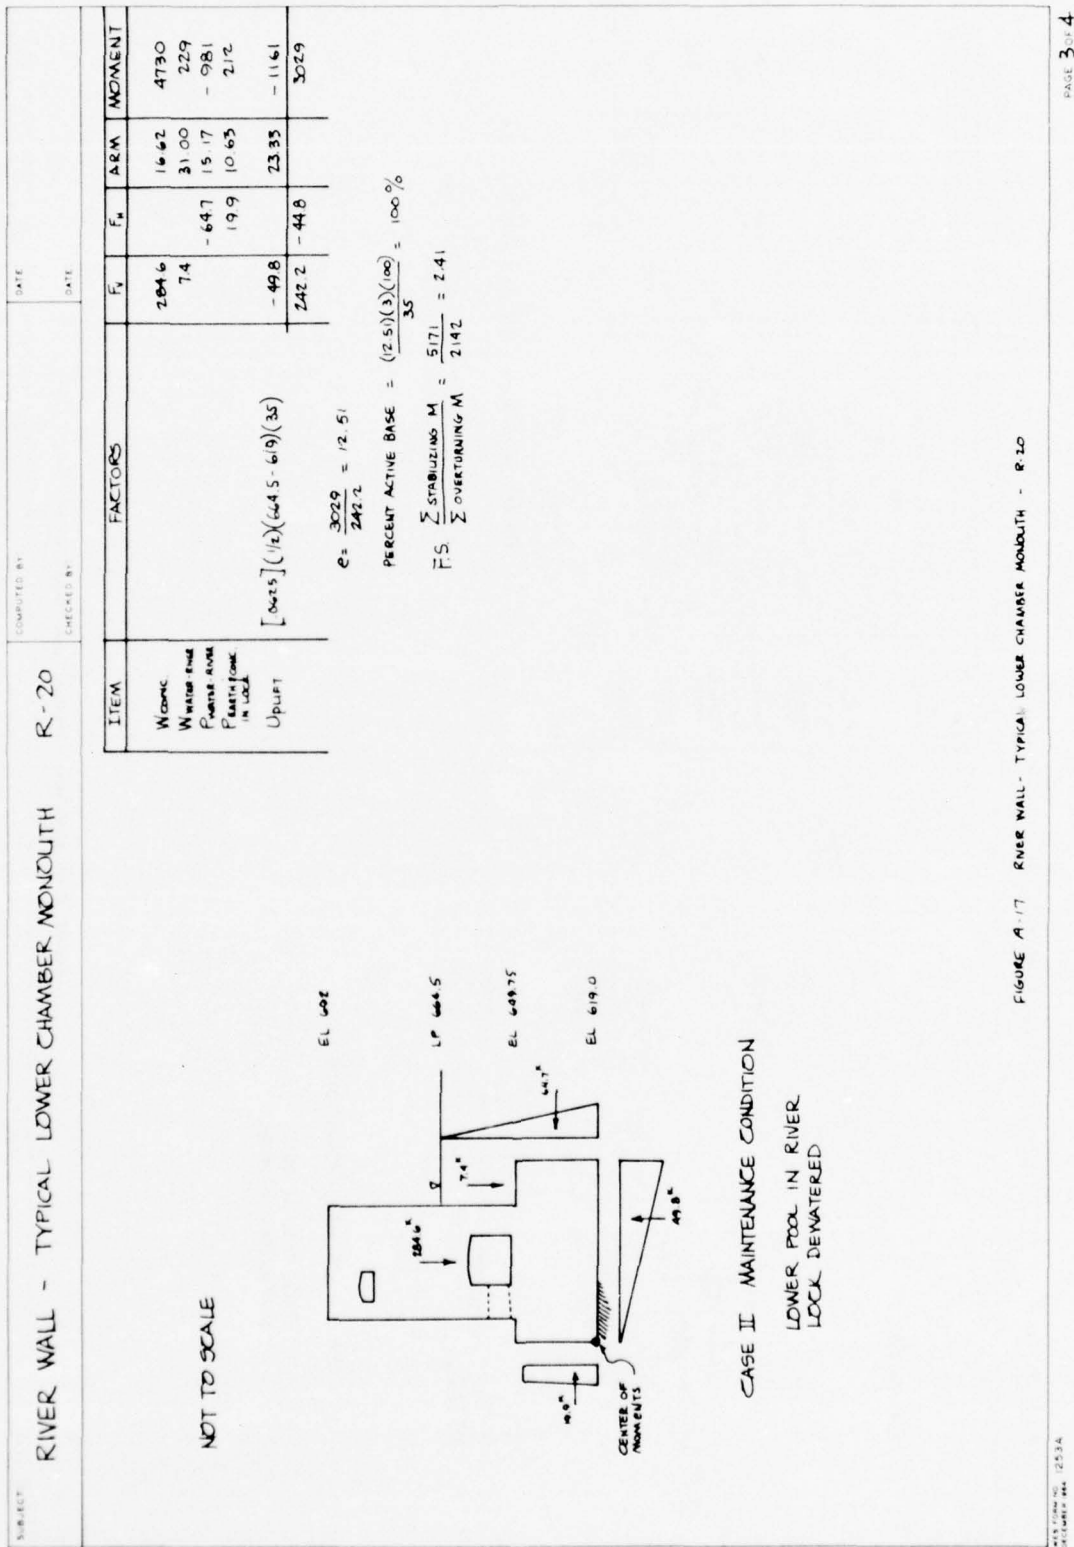
FIGURE A-17 RIVER WALL - TYPICAL LOWER CHAMBER MONOLITH R-20

SUBJECT	COMPUTED BY	CHECKED BY	DATE
RIVER WALL - TYPICAL LOWER CHAMBER MOUND LITH R-20			
<p>SLIDING</p> <p>CASE I NORMAL OPERATION</p> $R = \sum F_v \tan \phi + \text{KEY RESISTANCE}$ $= (188)(5658) + 0$ $= 1064$ $SSF = 106.4 / 80.1$ $= 1.33$	<p>BASE PRESSURE</p> <p>CASE I NORMAL OPERATIONS</p> $f = \frac{2}{3} \frac{P}{Q}$ $= \frac{(2)(188)}{(3)(35-26.74)}$ $= 15.2 \text{ KSF}$	<p>CASE II MAINTENANCE CONDITION</p> $f = \frac{P}{A} + \frac{M_c}{I}$ $= \frac{242.2}{55} + \frac{(242.2)(\frac{35}{2} - 12.5)(\frac{35}{2})(12)}{35^3}$ $= 6.92 + 5.92$ $= 12.8 \text{ KSF}$

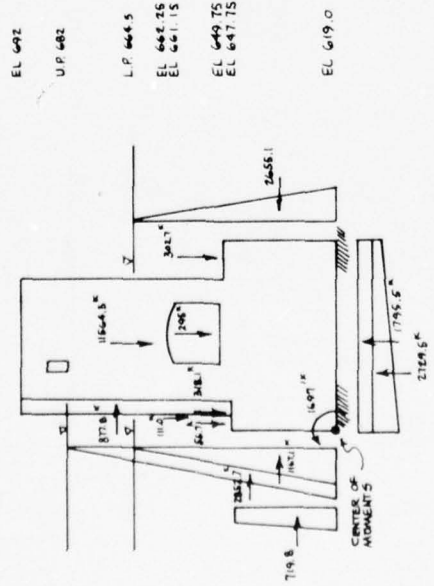
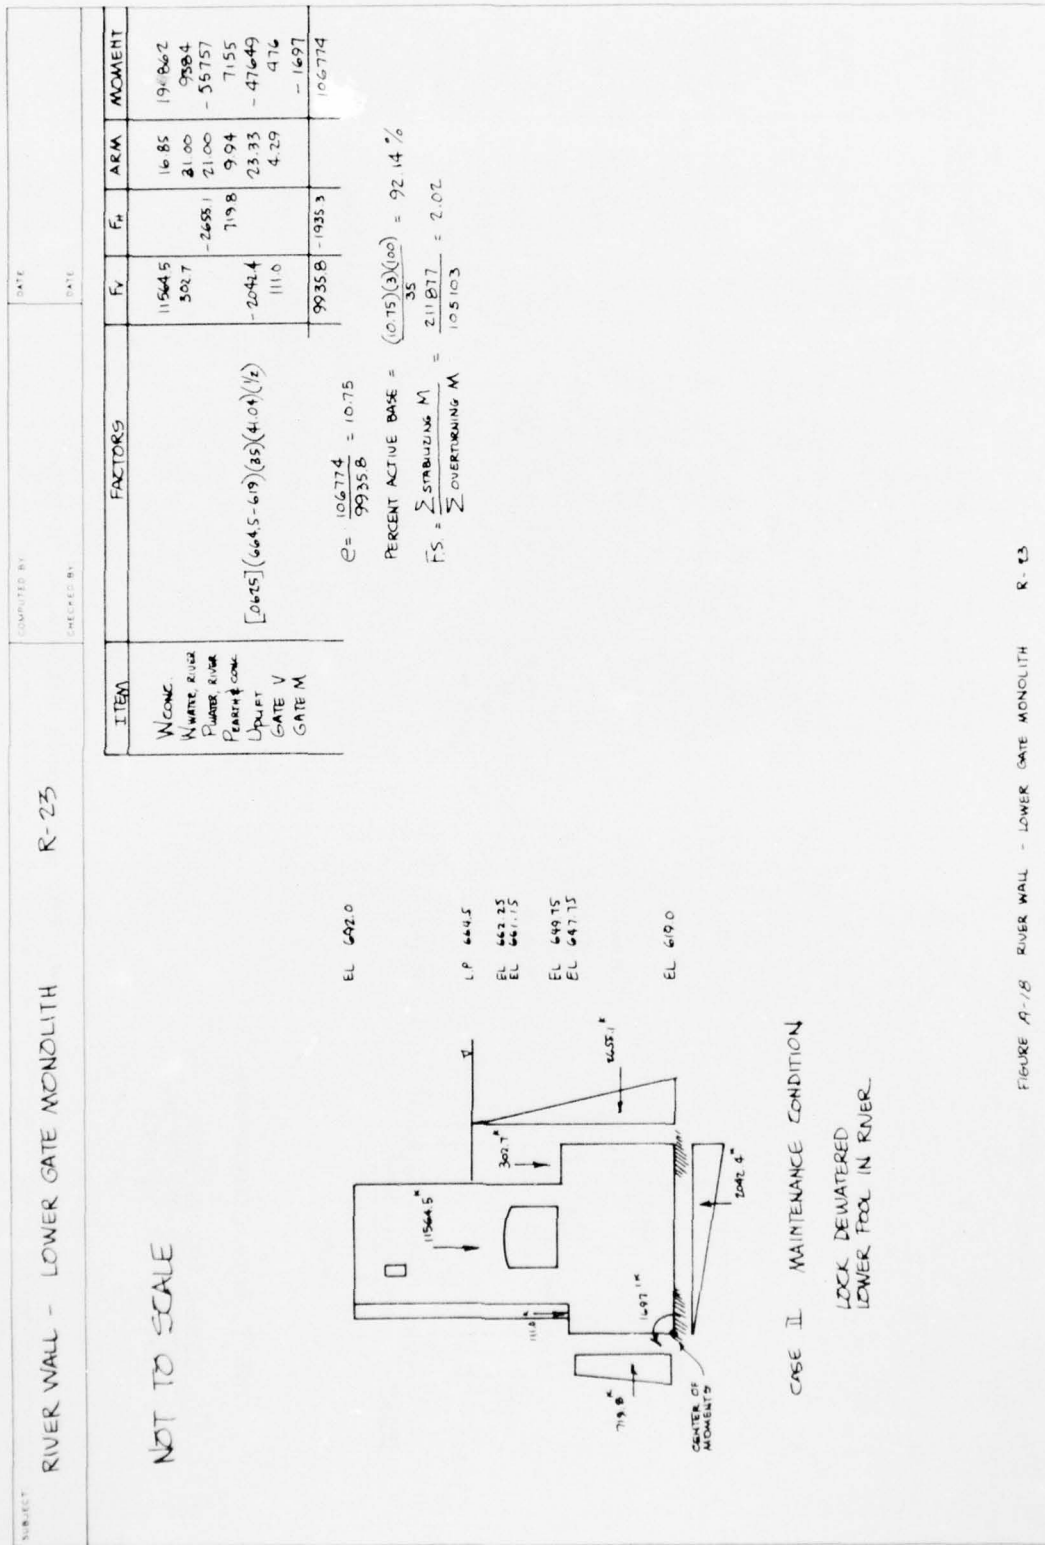
FIGURE A-18 RIVER WALL - LOWER GATE MONOLITH R-23

$$FS = \frac{\sum \text{STABILIZING M}}{\sum \text{OVERTURNING M}} = \frac{287338 \text{ L}}{254309.2} = 1.14$$

SUBJECT		COMPUTED BY	DATE
RIVER WALL - LOWER GATE MONOLITH R-23		CHECKED BY	DATE
<p>SLIDING</p> <p>CASE I NORMAL OPERATIONS</p> $R = \frac{\sum F_v \tan \phi + \text{KEY RESISTANCE}}{4596}$ $= \frac{(8123)(.5658)}{4596}$ $SSF = 4596 / 2962.3$ $= 1.55$		<p>BASE PRESSURE</p> <p>CASE I NORMAL OPERATIONS</p> $f = \left(\frac{2}{3}\right)\left(\frac{P}{e}\right)$ $= \frac{(2)(8123)}{(3)(35-24.53)} \div 41.04$ $= 12.60 \text{ KSF}$	
<p>CASE II MAINTENANCE CONDITION</p> $R = 9935.8 (.5658)$ $= 5621.7$ $SSF = 5621.7 / 1935.3$ $= 2.9$		<p>CASE II MAINTENANCE CONDITION</p> $f = \left(\frac{2}{3}\right)\left(\frac{P}{e}\right)$ $= \frac{(2)(9935.8)}{(3)(10.75)} \div 41.04$ $= 15.01 \text{ KSF}$

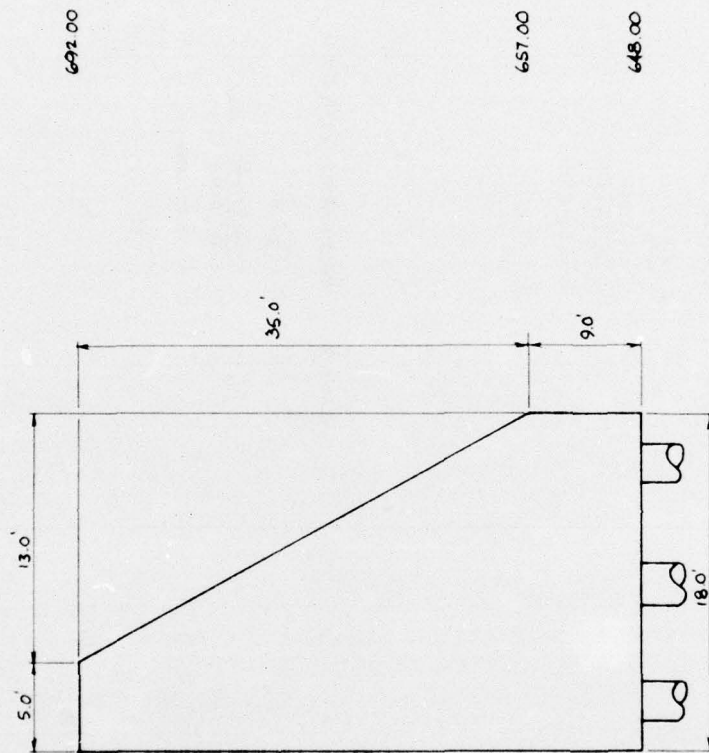
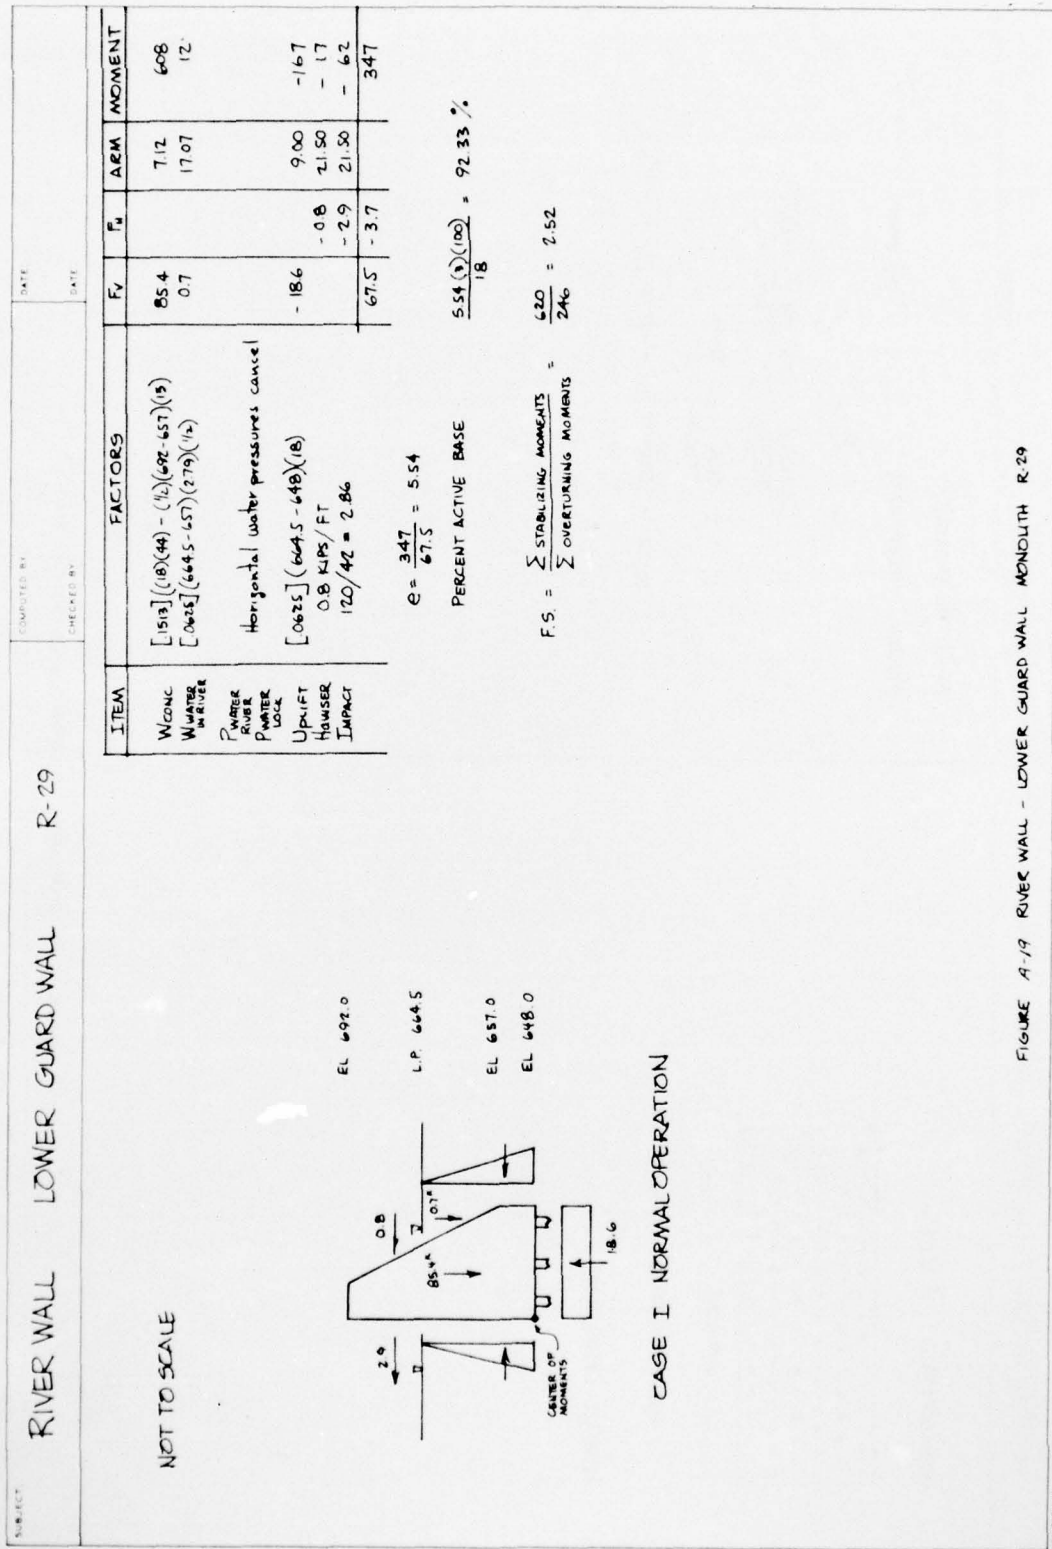
FIGURE A-19 RIVER WALL - LOWER GUARD WALL MONOLITH R-29

SUBJECT: RIVER WALL - LOWER GUARD WALL R-29	COMPUTED BY: _____ CHECKED BY: _____	DATE: _____ DATE: _____
HORIZONTAL PILE LOADS

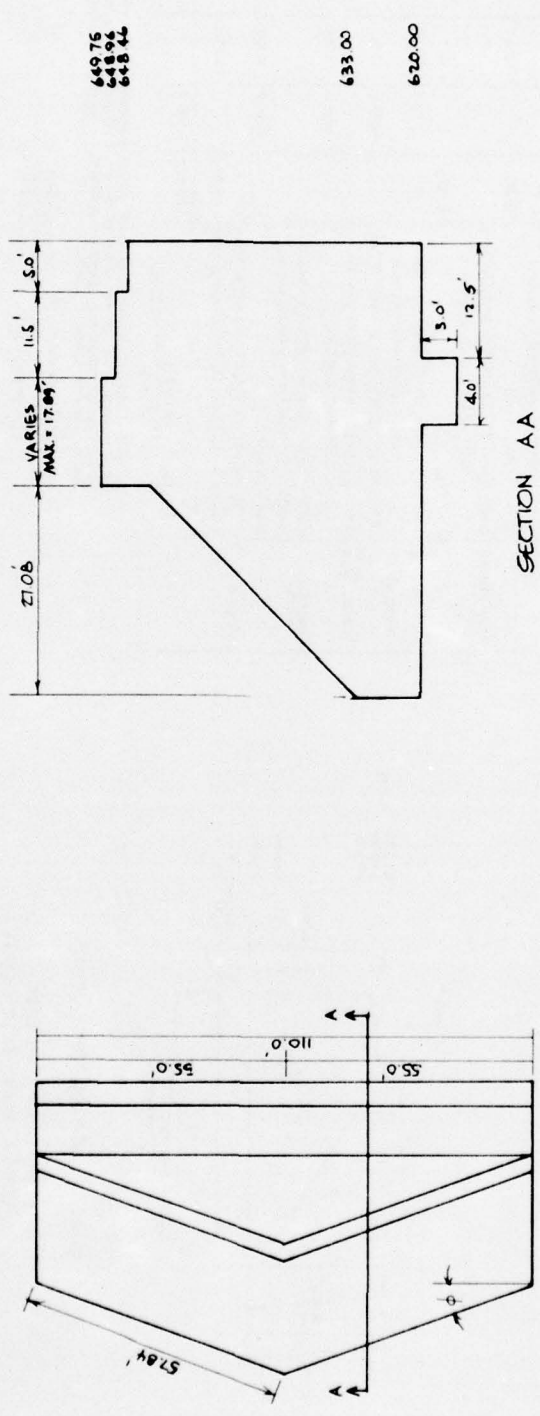
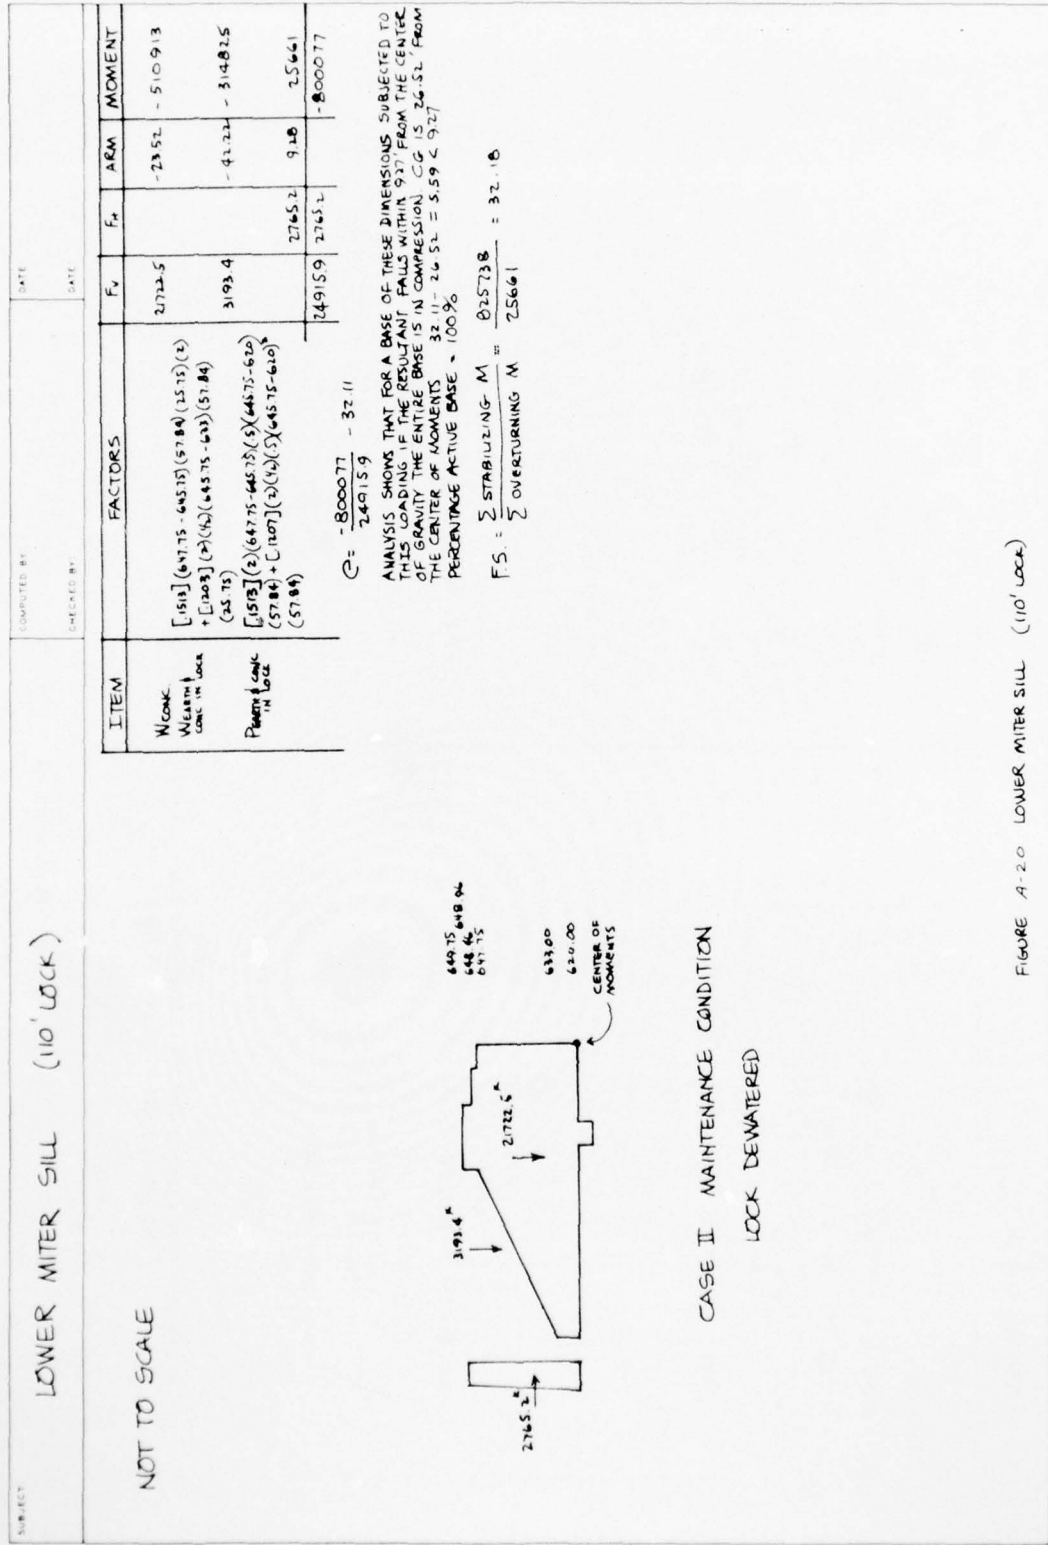
FIGURE A-2.0 LOWER MITER SILL (110' LOCK)

5.16 The miter sills are inadequate for sliding if the locks are dewatered.

SUBJECT	COMPUTED BY	DATE	CHECKED BY	DATE
<p>LOWER MITER SILL (110' LOCK)</p>				
<p>SLIDING</p> <p>CASE I NORMAL OPERATIONS</p> $R = \sum F_v \tan \phi + \text{Key Resistance}$ $= (15802.6 \times 5650) + (4)(110 \times 0.75)(144)$ $= 8941.1 + 4752$ $= 13693.1$ $SSF = 13693.1 / 5049.7$ $= 2.71$	<p>BASE PRESSURES</p> <p>CASE I NORMAL OPERATION</p> $f = \frac{P}{A} + \frac{M \cdot c}{I}$ $= \frac{15802.6}{5777.8} + \frac{(15802.6)(26.52 - 21.92)(26.52)}{1409872}$ $= 2.74 + 1.07$ $= 3.81 \text{ KSF}$	<p>CASE II MAINTENANCE CONDITION</p> $f = \frac{P}{A} + \frac{M \cdot c}{I}$ $= \frac{24915.9}{5777.8} + \frac{24915.9(32.11 - 26.52)(61.47 - 26.52)}{1,409,872}$ $= 4.31 \quad 3.46$ $= 7.77 \text{ KSF}$	<p>NOTE THE ANALYSIS FOR THE UPPER MITER SILL (110' LOCK) WAS FOUND TO BE ADEQUATE AND STABLE AND HAS NOT BEEN PRESENTED HERE.</p>	
<p>FIGURE A-20 LOWER MITER SILL (110' LOCK)</p>				<p>PAGE 4 OF 9</p>
